PJ'S BASS LAKE DAM
ST FRANCOIS COUNTY, MISSOURI
MO 31189

PHASE 1 INSPECTION REPORT NATIONAL DAM SAFETY INSPECTION

JUNE 1981

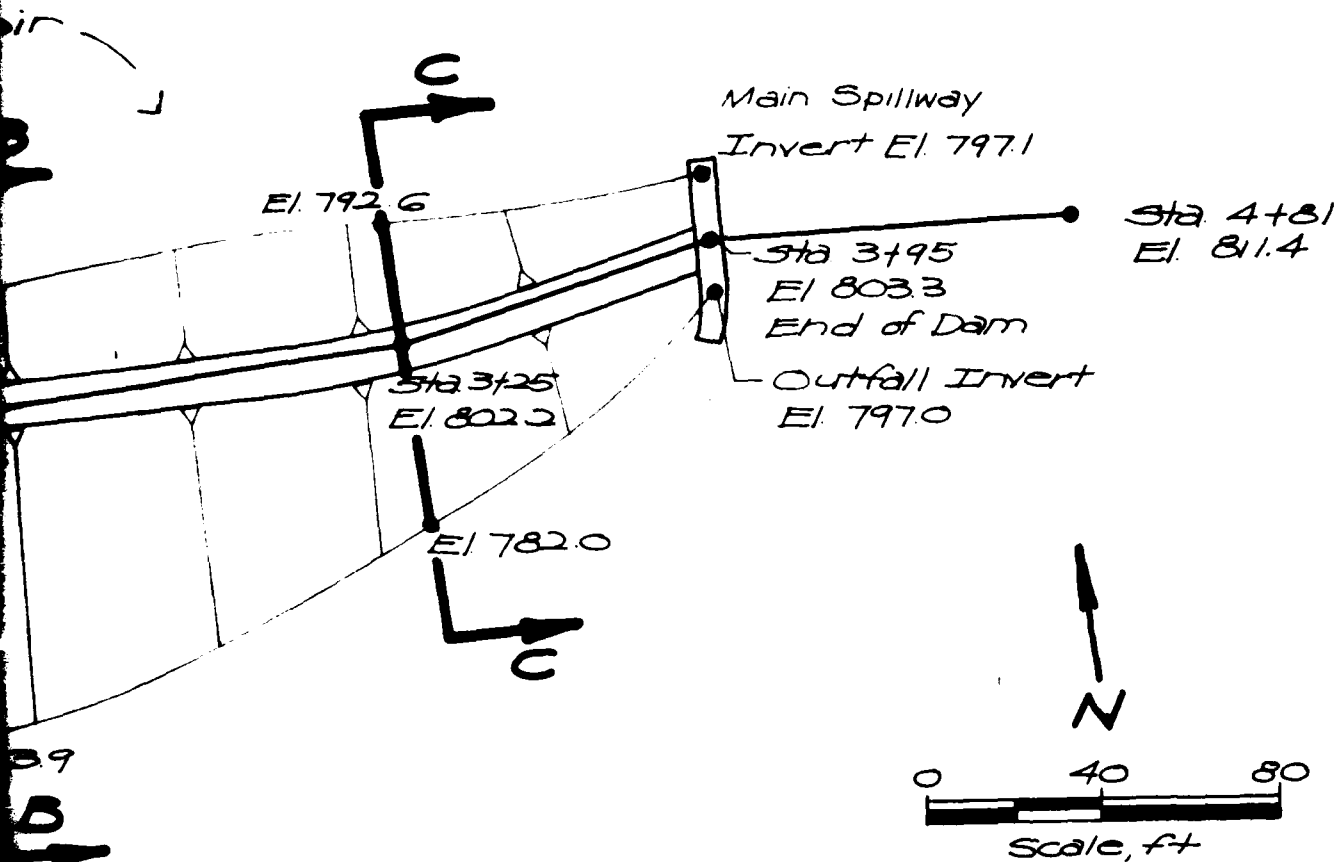
Fig. 3-A

- a. Visual inspection. The visual inspection identified no signs of cracking, sinkhole development, or animal burrows on the embankment. The field survey noted minor settlement had occurred near the center of the embankment (Fig. 3A). Seepage was noted at the toe of the dam. This was reported by Mr Hunt as a spring which existed prior to the building of the dam. If this is the case, it does not appear that any special precaution was taken during construction to install a filter over the spring. Total seepage flow was estimated at 5 gal/min. The seepage water did not appear to be transporting any soil, and was not considered to pose a hazard to the stability of the dam at the time of the inspection.
